## Root cause of vane damage identified: inadequate filter design

# NEWS: focus on combined cycle power plants

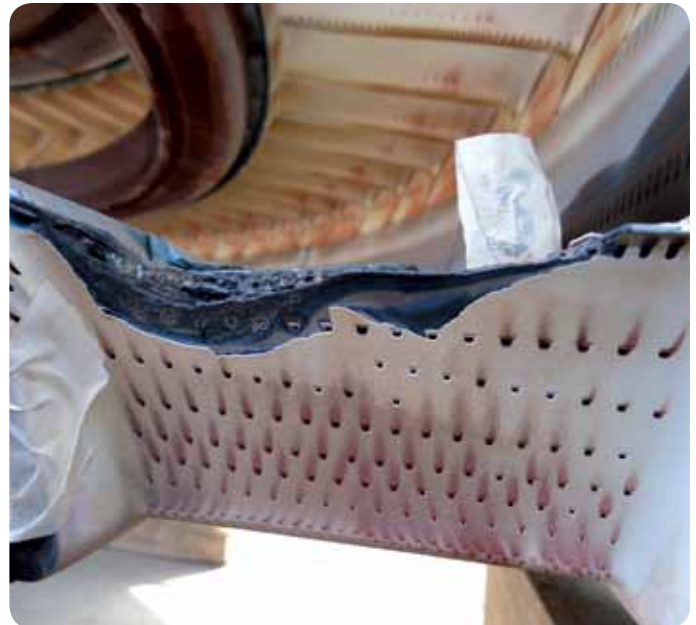
*The plant operator feared that replacing the vanes was a treatment of the symptoms and called in Laborelec for a second opinion.*

After 24,000 hours of operation, the turbine manufacturer had replaced the first-stage vanes due to overheating at the trailing edge. However, the cause of the overheating was unclear and, what's more, the problem seemed to reoccur after less than 10,000 operating hours. Therefore, the plant operator feared that replacing the vanes was a treatment of the symptoms rather than a sound solution to the underlying problem. Consequently, the maintenance team called in Laborelec for a second opinion.

First, Laborelec materials and chemical experts carried out visual inspections and chemical analyses of compressor samples. Roughness measurements confirmed that the erosion rate of the compressor blades was higher than expected. We then inspected the turbine section and the filter compartment, which revealed that many cooling holes on the vanes were clogged by iron oxide and sulphur-containing material. The vanes themselves were affected by oxidation and corrosion. More important, puddles of brackish water were found in the filter compartment. Our experts subsequently analyzed the filter design and determined that it was inadequate for draining humidity.

Kurt Boschmans explains, 'Our investigations showed that while the coalescent filter material itself was adequate, the overall compartment was designed for a dry environment. This was a mistake. Although it rarely rains in Chilca, the air there is humid due to the coastal location. Without proper drainage, the filter material gets soaked and becomes useless. This discovery was crucial to the implementation of a new, effective filter design.'

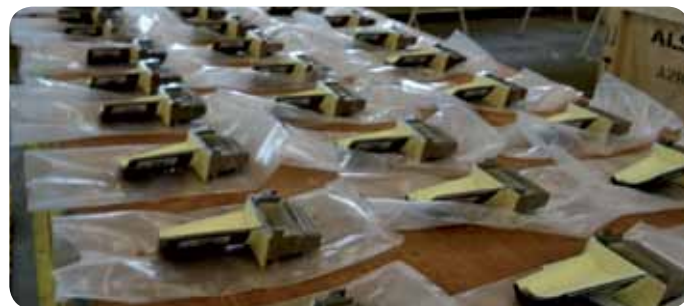
*Our experts carried out a number of tests to assess coating quality and other characteristics.*

Another important characteristic of the equipment is coating quality. Laborelec therefore carried out several non-destructive tests to assess the coatings applied on a variety of components. 'For instance, using eddy current technology, we measured the ceramic coating thickness. For components with metallic coatings, we made ultrasonic measurements to verify that the coating correctly adhered to the surface. We also used FSECT technology to assess the quality of the bond coat in between the ceramic layer and the material,' elaborates Degive. These tests revealed no abnormalities, thus ensuring Sharepart that the spare part coatings complied with quality standards.

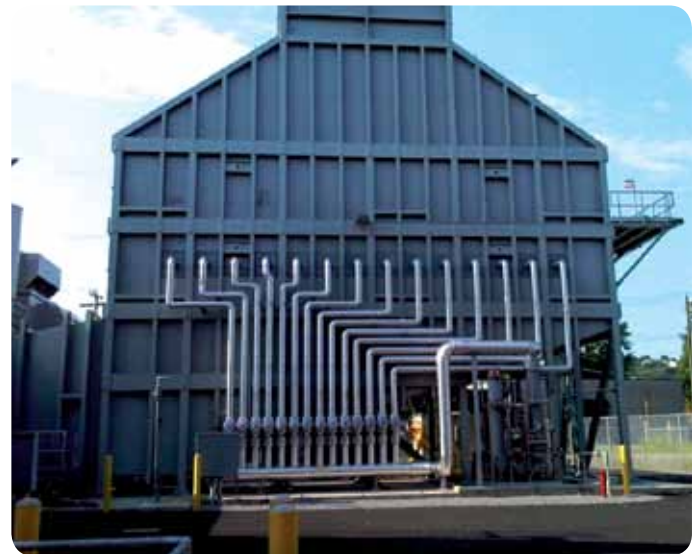
*Catalysts may be necessary in CCGT units when emission standards are too strict.*

Laborelec has extensively studied the on-site use of SCR and SCO technology in the USA. 'When regulation limits NO<sub>x</sub> emission to a few ppmv, as is the case in several states in the USA, CCGT units often need catalyst technology,' adds Henry. 'Because of this study, we are now able to better determine when an SCR or SCO is necessary, where to install it, how to size it, and how to operate and maintain it.'

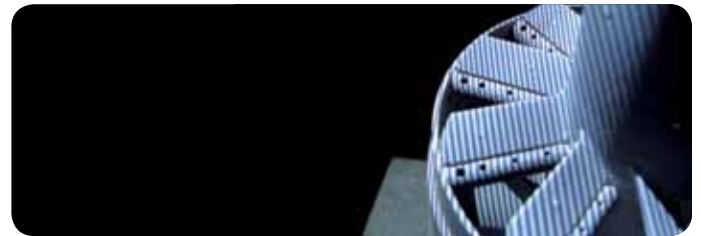
*When the tuning is too tight, the flame can become unstable, inducing fluctuations in pressure in the combustion chamber.*

However, operators are increasingly keen on understanding more about the tuning process. Laget explains, 'Tuning always involves a compromise between reducing emissions and providing a stable, reliable flame. When the tuning is too tight, the flame can become unstable, inducing fluctuations in pressure in the combustion chamber, and ultimately decreasing the equipment's life expectancy. There is thus a balance to be struck between production efficiency and eco-efficiency.' For this reason, Laborelec provides on-site support during tuning works. 'We analyze the manufacturer's proposals and ensure that the plant's priorities are taken into account,' states Laget. Additionally, Laborelec provides plant operators with comprehensive tuning guidelines for a number of well-known burners.

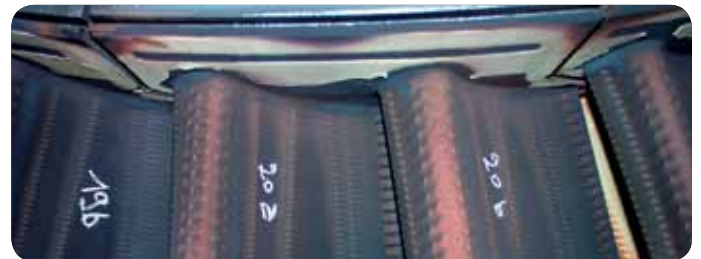
*Remote monitoring identified a potentially dangerous temperature increase which led to the remedial action avoiding damage to the stator blades.*

SmartSignal is a tool that detects abnormal behaviour by comparing actual data with expected values. The SmartSignal data for the gas turbine showed a significant wheel space temperature increase from 420 to 460 °C, indicating a probable malfunction in the cooling circuit. Such an event must immediately be investigated. It causes an increase in the temperature of the stator blades, which, in turn, can accelerate the blade ageing process.

'We instantly informed the plant operators of the problem and advised them to verify that the compressor air bleed piping was not blocked and that all valves were in the correct position,' recalls Sébastien Gregoire. During their inspections, the operators discovered a closed valve on the compressor bleed piping that should have been open. 'The valve had been closed for an offline compressor wash before the start of the unit in order to prevent cleaning products from entering the piping. After the wash, the valve had not been reopened correctly.'
